UNDERWATER BRIDGE INSPECTION REPORT

STRUCTURE NO. 2366

MISSISSIPPI RIVER

JOB NO. 5221 (CEI 34)

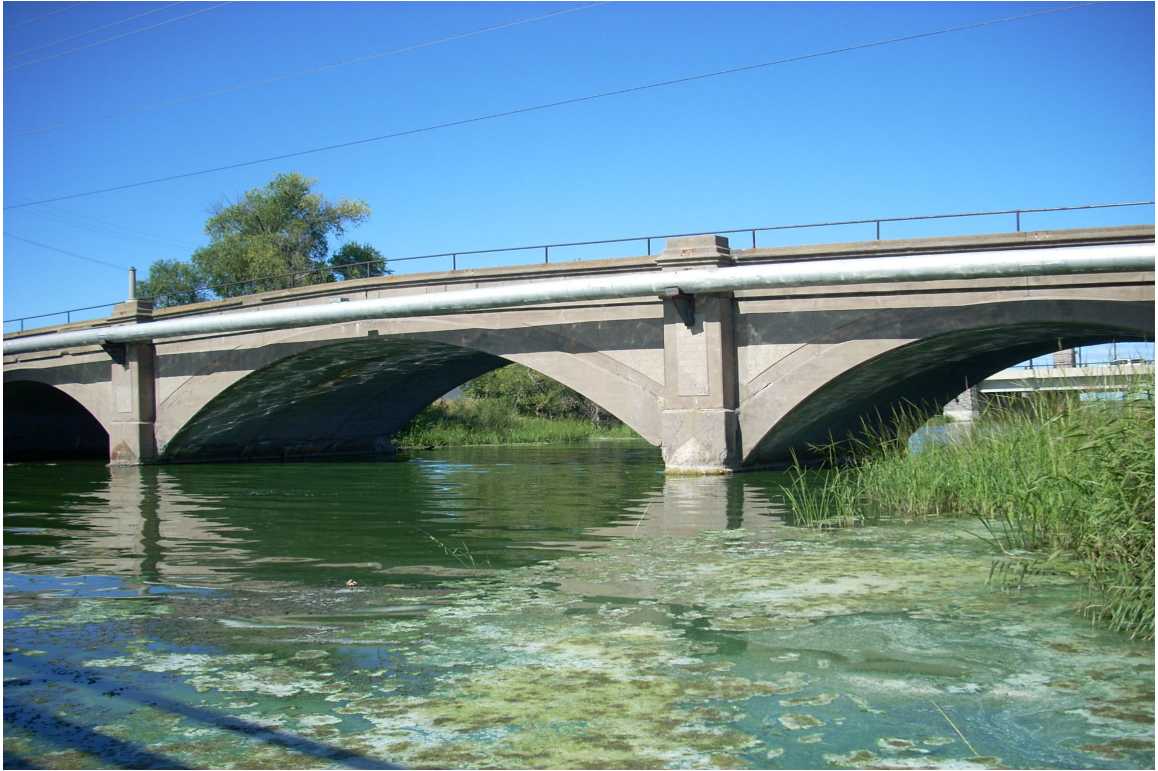
Photograph 1. Overall View of Structure, Looking Northwest.

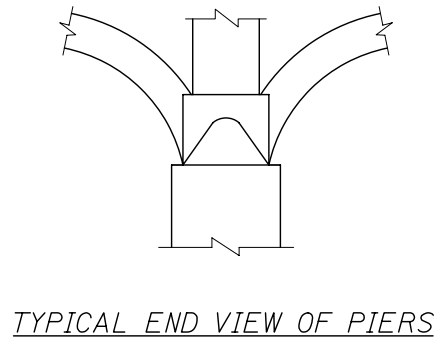
- INSPECTION NOTES:
- The channel bottom material consisted of firm sandy gravel and cobbles with 2 to 3 inches of probe rod penetration.
 - Below the waterline concrete of the east abutment was smooth and sound with a light layer of aquatic growth and no defects of structural significance observed.

- A moderated accumulation of timber debris, including a 20-foot-long by 1-foot-diameter log, was observed extending from the West Abutment to the downstream end of Pier 1.

- Band of scaling, impending spalling, spalling with exposed and corroded rebar, and section loss around both piers typically located between 1 foot below and 3.5 feet above the waterline, with typical penetrations of 2 to 3 inches and maximum penetrations of 6 to 12 inches. The heaviest deterioration was located at the upstream pier noses and along the east side of Pier 1 and the west side of Pier 2.

- Area of section loss was observed at midpoint on west face of Pier 1, 1 foot long by 2 inch high, 2 feet below the waterline with 2 inches of maximum penetration.

- Random hairline to 1/16-inch-wide map cracking with light amounts of efflorescence were observed on the west abutment from the channel bottom to 3 feet above the channel bottom.

- Shopping cart was observed on the channel bottom at the downstream quarter point adjacent to the west face of Pier 1. Other debris was also located randomly between Pier 1 and West Abutment.
